**ASBESTOS IDENTIFICATION SURVEY  
AND HAZARDOUS MATERIALS ASSESSMENT  
HALLOWELL FIRE DEPARTMENT BUILDING  
HALLOWELL, MAINE**

**Summit Environmental Consultants, Inc.  
8 Harlow Street, Suite 4A  
Bangor, Maine 04401**

**September 4, 2009  
Project 16937**

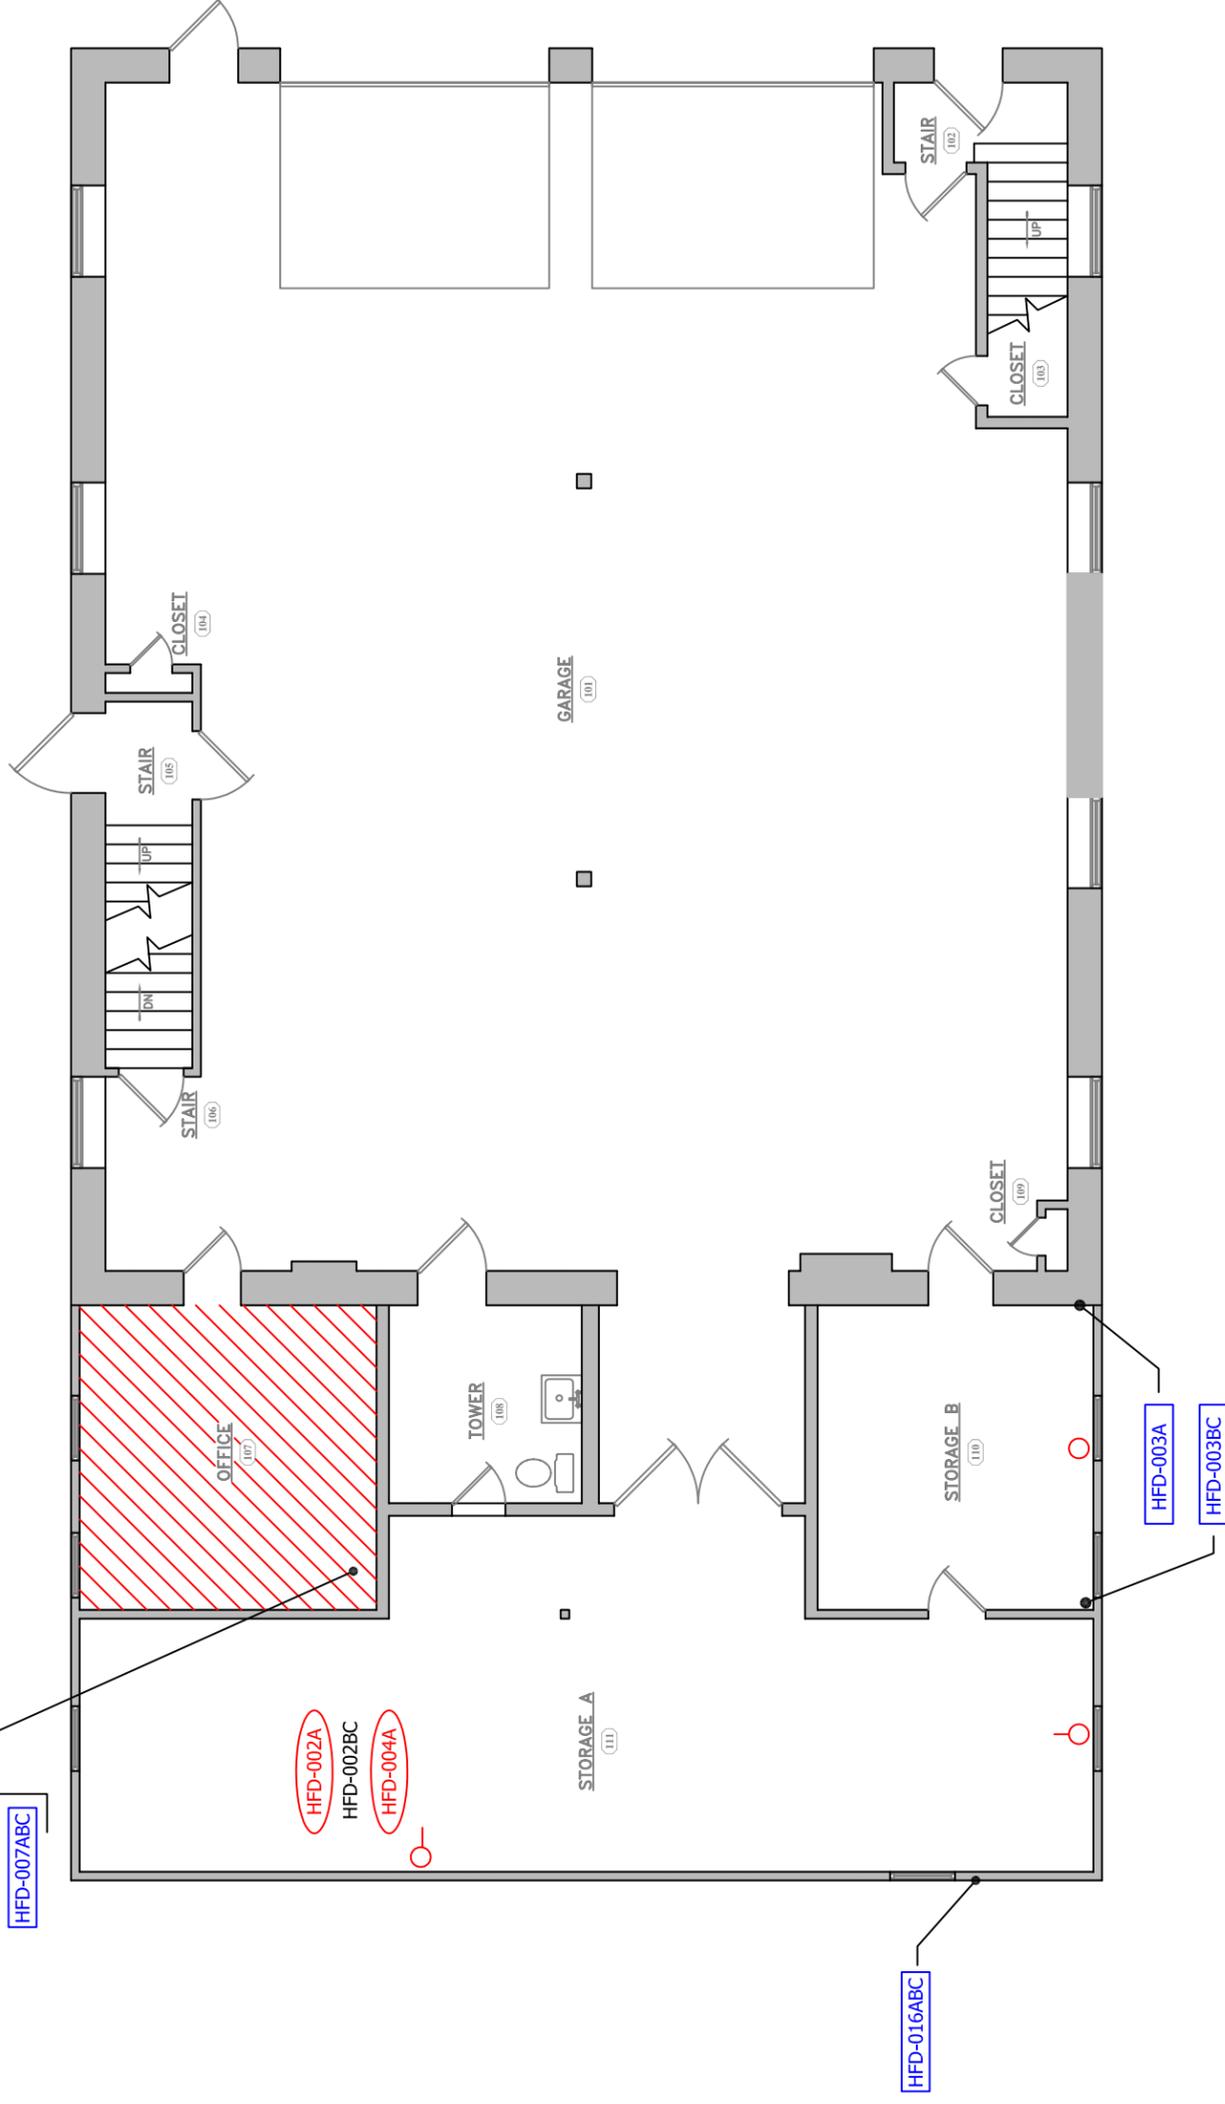
**FIRST FLOOR PLAN - ASBESTOS**

| LEGEND | |
|---|--|
| | = ACM FLOOR TILE WITH NON-ACM ADHESIVE UNDER CARPET |

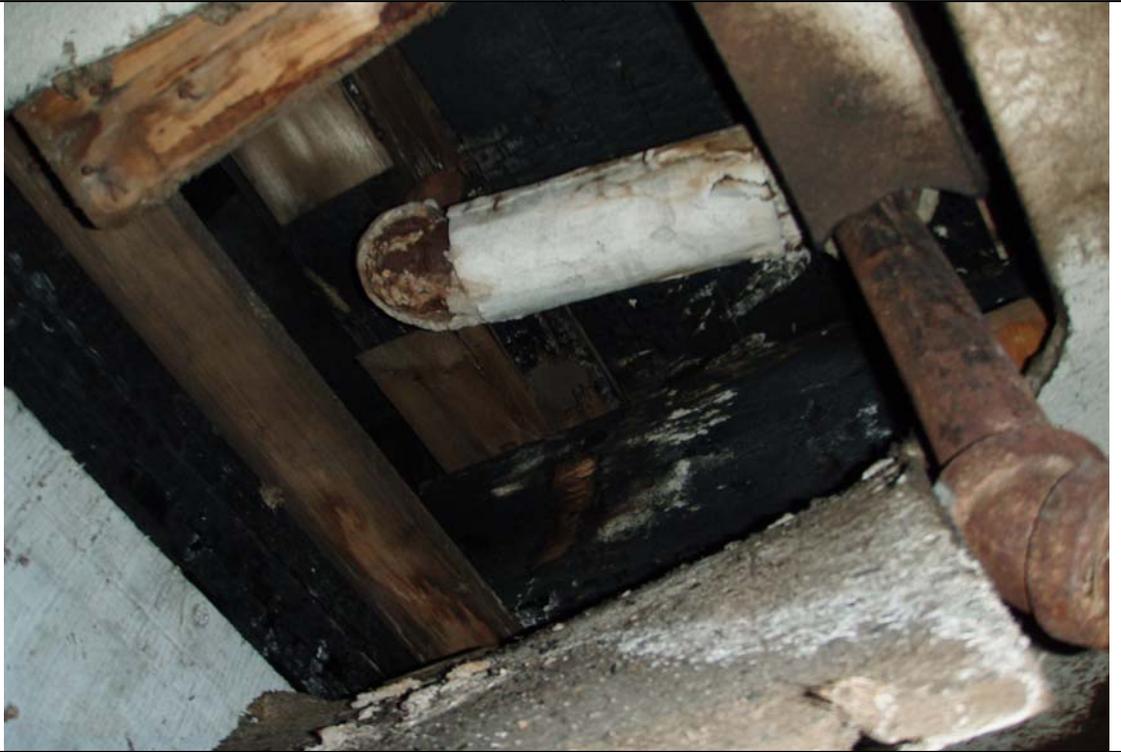
**Photo No. 2**

2. ACM pipe insulation present within the First Floor exhibited areas of localized damage and is recommended for removal.
3. ACM present throughout the building should be managed under a comprehensive Operations and Maintenance (O & M) program.
4. Those ACM impacted by future renovation/demolition must be removed prior to commencement of these activities.
5. ACM abatement must be performed using approved methods in accordance with applicable regulations established by the U.S. Environmental Protection Agency (USEPA), Occupational Safety and Health Administration (OSHA) and Maine Department of Environmental Protection (MEDEP). These recommendations are based upon observations of conditions at the time of this survey.

**Description:**  
Asbestos pipe insulation  
located above ceiling in  
Storage Room A – First  
Floor.

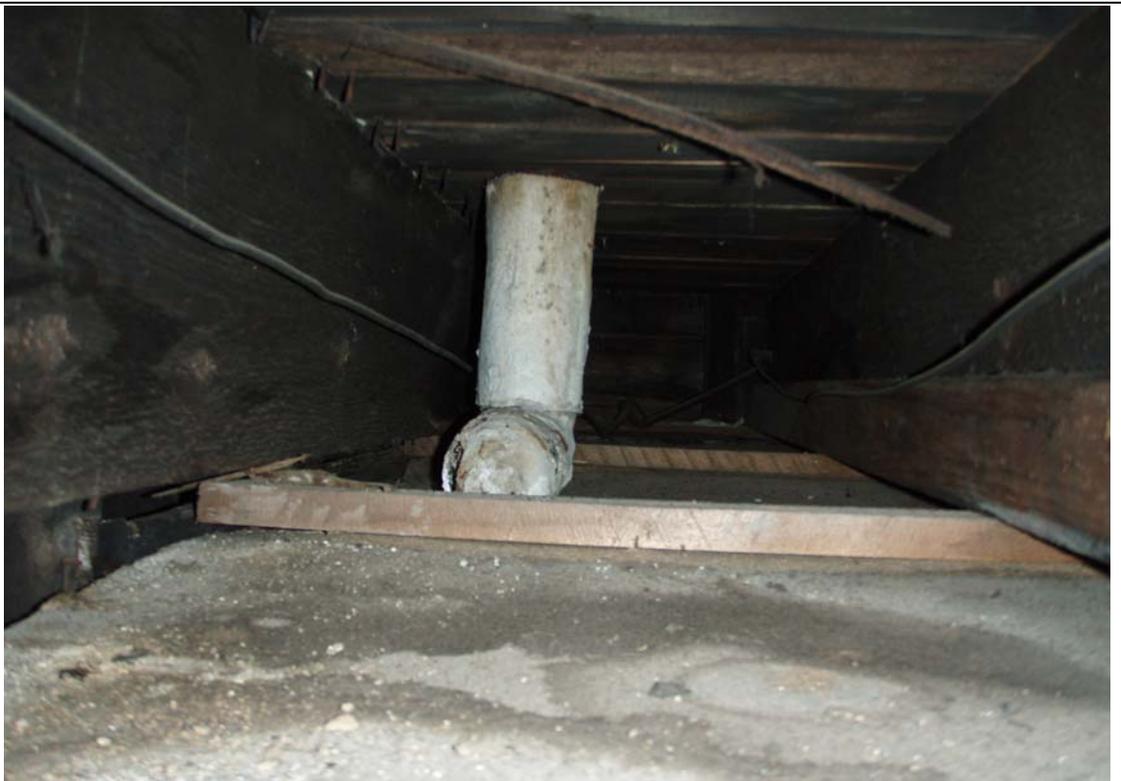
**Description:**  
Asbestos pipe insulation  
present above  
sheetrock ceiling in  
Storage Room B - First  
Floor.

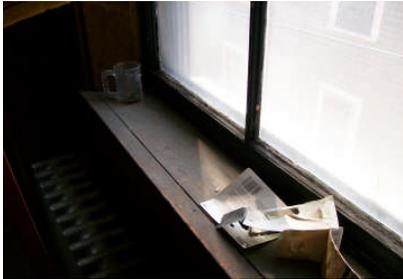
Photo #9; L-28 Window Sashes

| FIELD ID # | SAMPLE LOCATION | COMPONENT(S) | COLOR | CONDITION | # OF RDGS | RESULTS |
|---|---|---|---|---|---|---|
| L-28 | SECOND FLOOR; LIVING ROOM<br>(SASHES ARE STAINED) | WINDOW EXTERIOR<br>TRIM | WHITE | POOR | 1 | >9.9 |

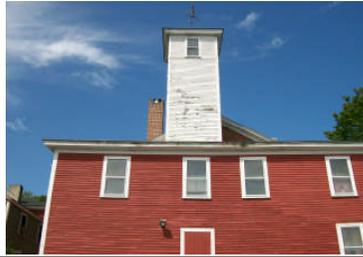
Photo #14; L-21,22,34 'C' side Siding/Cornerboards/Trim/ Tower

The exterior of the main building is bare brick with painted trim work that tested positive or is assumed positive for lead; the rear section of the building is covered with leaded wood clapboards and trim, in deteriorating condition. The Tower, inaccessible for testing, is comprised of wood clapboards, wood upper trim, windows/window trim and miscellaneous trim. All of these components have been assumed positive for lead based on the results of testing from lower wood components.
