**ASBESTOS IDENTIFICATION SURVEY  
AND HAZARDOUS MATERIALS ASSESSMENT  
HALLOWELL FIRE DEPARTMENT BUILDING  
HALLOWELL, MAINE**

**Summit Environmental Consultants, Inc.  
8 Harlow Street, Suite 4A  
Bangor, Maine 04401**

**September 4, 2009  
Project 16937**

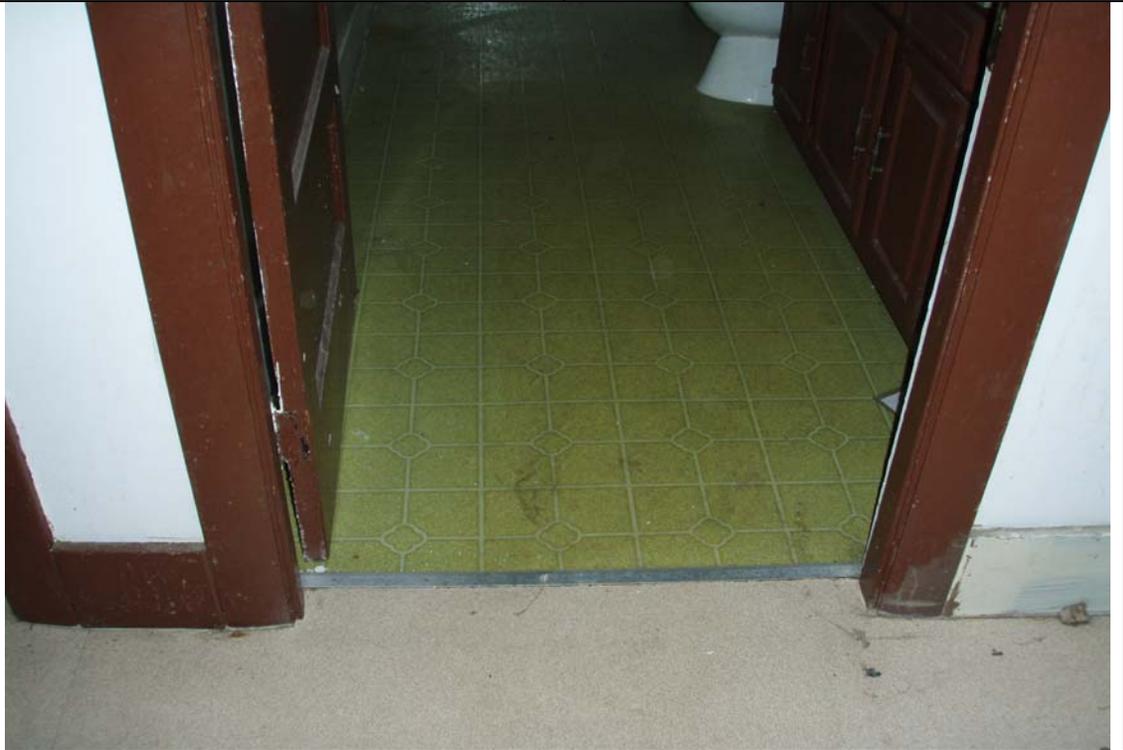
**Site Location:**  
Hallowell Fire  
Department

**Description:**  
Second Floor apartment  
rest room showing  
asbestos sheet flooring.
